**INTEGRATED WASTE WATER MANAGEMENT PLAN**

**PROPOSED HELMSLEY COUNTRY ESTATE LOCATED IN  
COMPENSATION, KWAZULU-NATAL**

**February 2019**

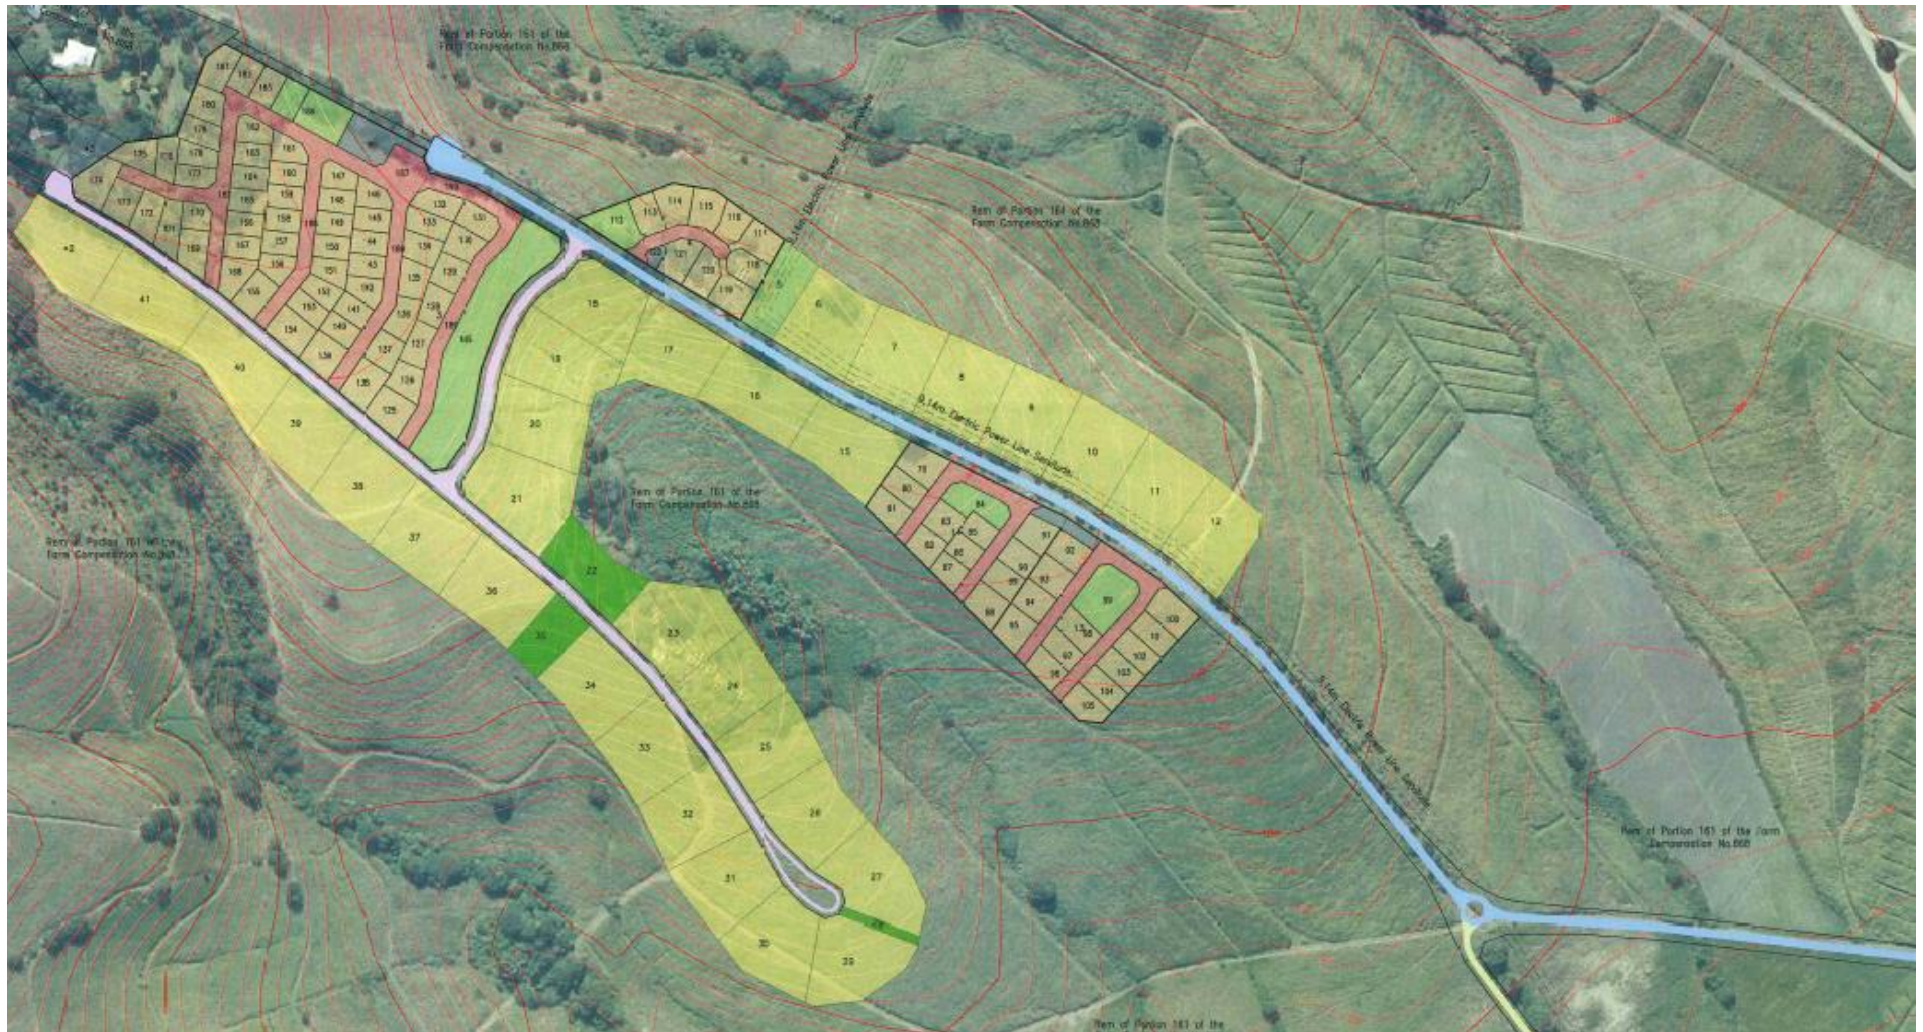
Figure 2.1: The proposed Helmsley Country Estate Layout

The proposed 21,0801ha Helmsley Country Estate development will comprise of 32 full title individual special residential type I stands and 93 sectional title units on 5 medium density residential type II and III stands. The associated infrastructure required to support the residential development includes: the upgrading of existing farming tracks on the property to tar roads, the provision of electricity, the construction of a sewage treatment facility, the supply and treatment of borehole sourced water, storm water management, solid waste management and the installation of Telekom telephone lines. Please see **Figure 2.1** below containing the design of the proposed Helmsley Country Estate.

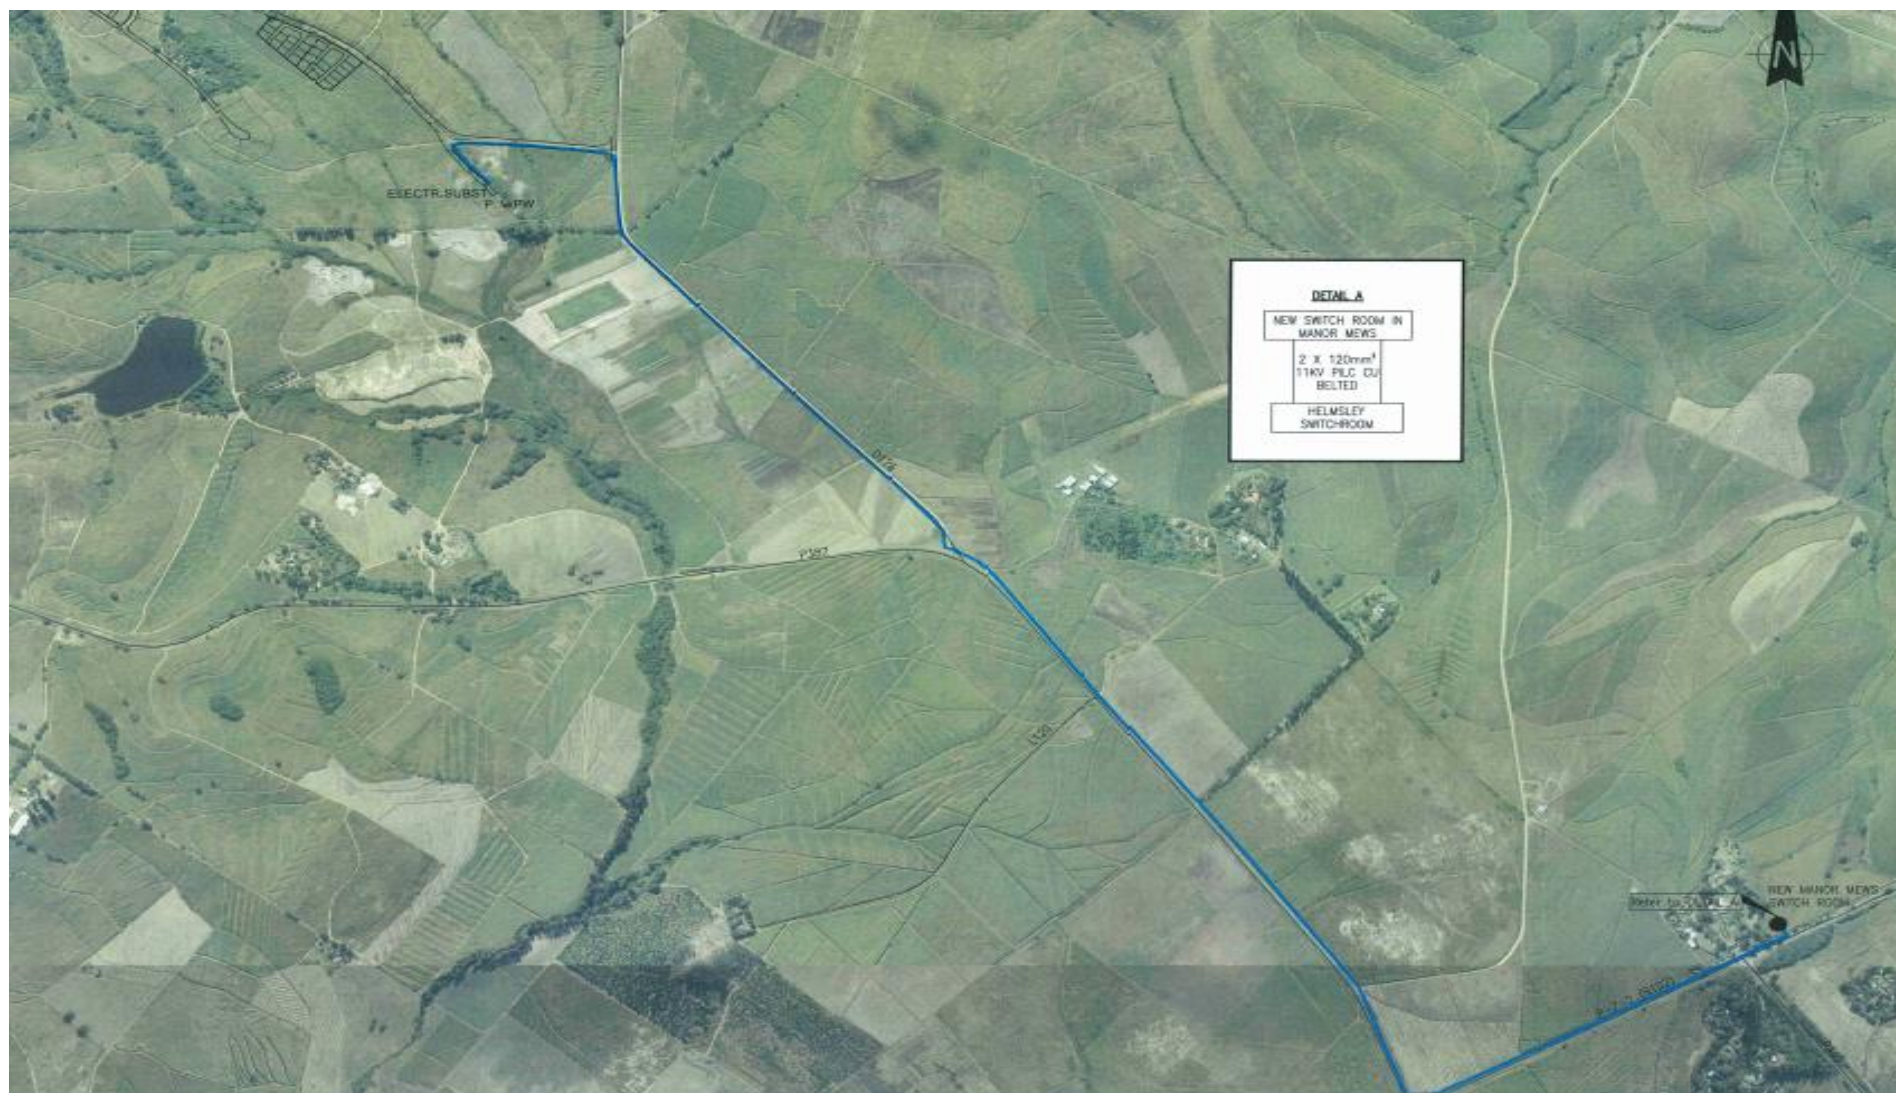
Figure 2.3: Option 1 Electricity provision option. Manor Gardens to Helmsley Country Estate

Option 2 involves the construction of a 33kV overhead electrical power line to the estate and the installation of a 33/11kV 5MVA step down substation. The land for this substation and overhead line option would have to be secured and made available for same.

The supply authority responsibility shall cease at this 11kV bulk supply metered point of control. Responsibility for the maintenance and upkeep of estate internal 11kV reticulation cables, associated mini substations/transformers, low voltage cables/distribution kiosks and street lighting infrastructure shall remain vested with the Developer/Body Corporate/Homeowners Association.

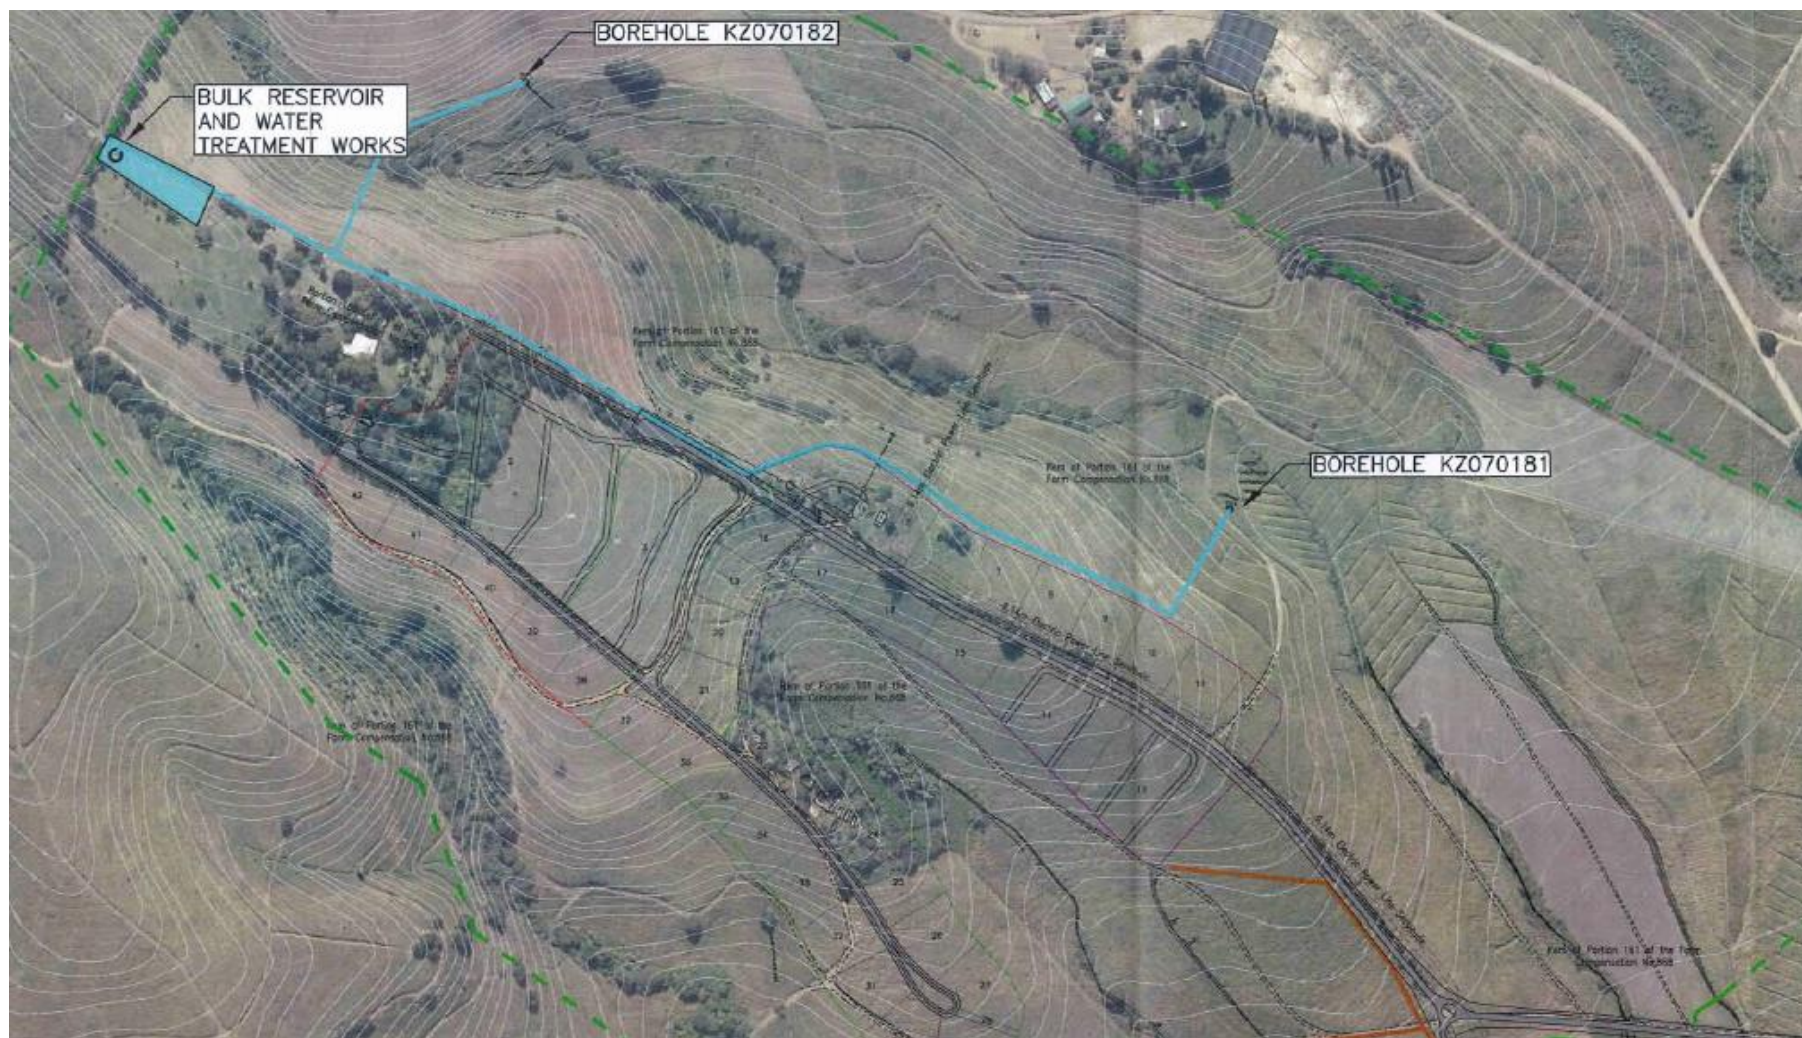
Figure 2.4: Location of boreholes and package plant in relation to the development

An updated geohydrological assessment (**Appendix 13**) was undertaken in 2019 by GSC. Two production boreholes, BH KZN070181 and BH KZN070182 are located within the site boundaries. These boreholes were drilled and aquifer tested by Geomeasure Group during 2007 (the first geohydrological assessment). Based on the evaluation of the existing data, GCS agrees with the findings of the aquifer tests performed. The sustainable yield for BH KZN070181 was 5 l/s and the recommended daily pump cycle is for 8 hours. BH KZN070182 has a sustainable yield of 6.94 l/s and the recommended daily pump cycle is for 12 hours. The total volume that can be abstracted is 443.81m<sup>3</sup>/day.

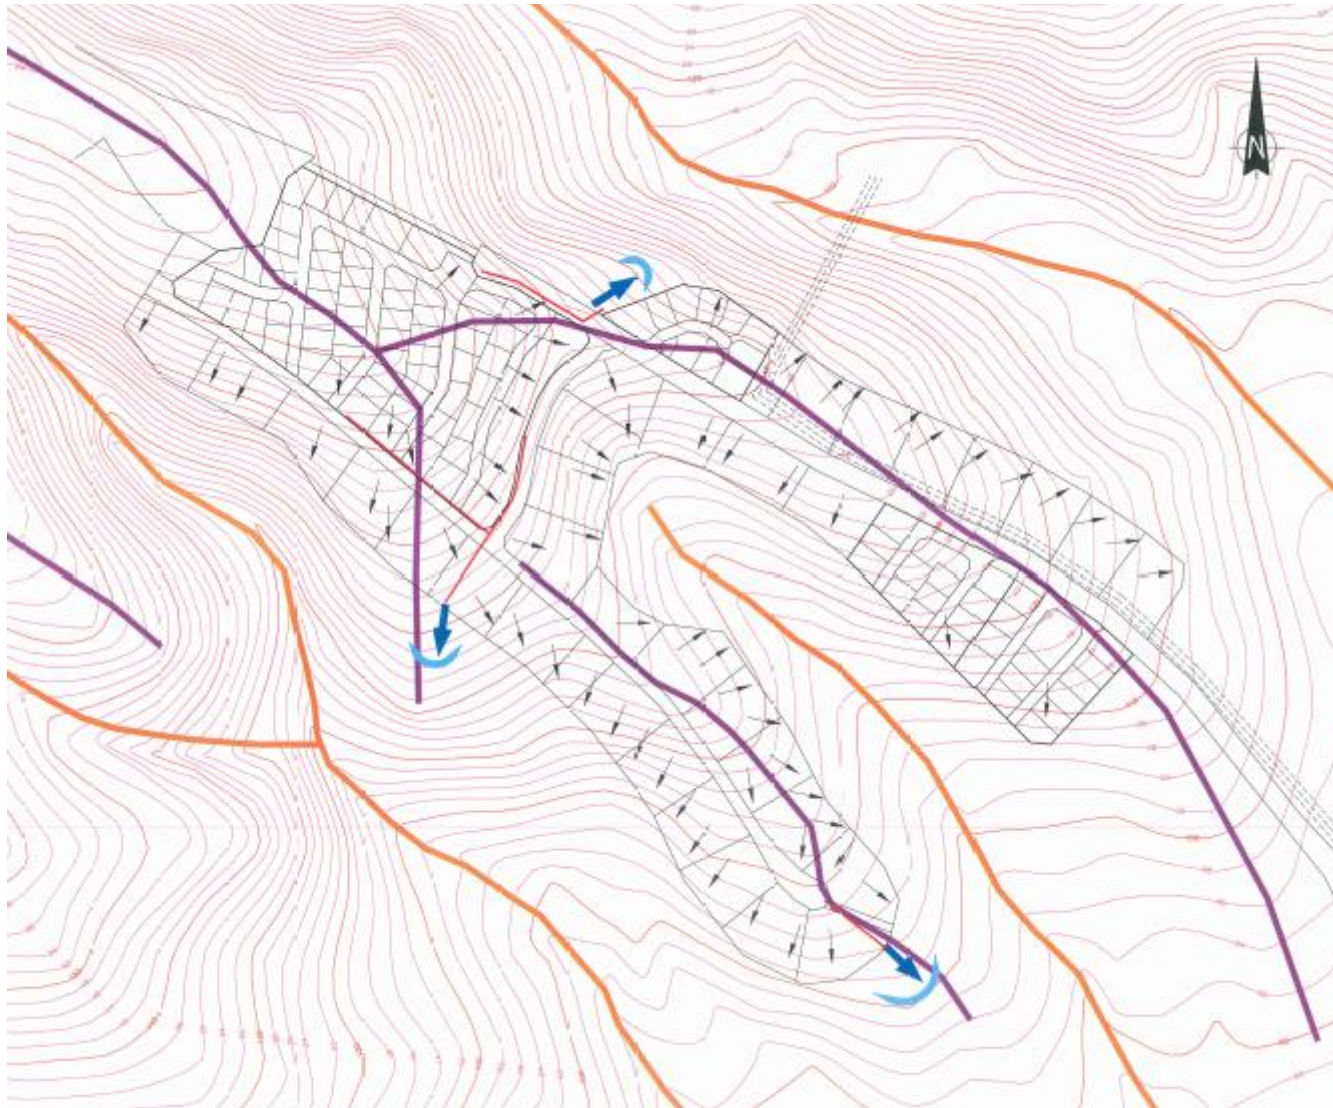
Figure 2.7: Stormwater management for the proposed Helmsley Country Estate

There are existing stormwater culverts on the Helmsley farm where the main entrance road crosses three watercourses on route to the D176 road. Access routes to the site must follow the existing access roads or cane haulage roads, already established on the site. Prior to moving onto site, the Engineer and Contractor shall inspect the existing stormwater drainage measures along these access routes and repair or construct new drainage measures to limit point source run-off, prevent erosion and allow for the natural flow of water. Major culverts will be required in low laying areas and appropriately located in areas where roads cross natural drainage courses/valley lines. A rehabilitation plan ([Appendix 12](#)) has been formulated to deal with the development within a watercourses.

It is important to note, according to the Determination of the 1:100 year Floodlines at the proposed Sanitation Plant for Helmsley Housing Development Report, the development as intended, will have a

very limited effect on the post development run-off flood volumes of each of the different catchments in the project area.

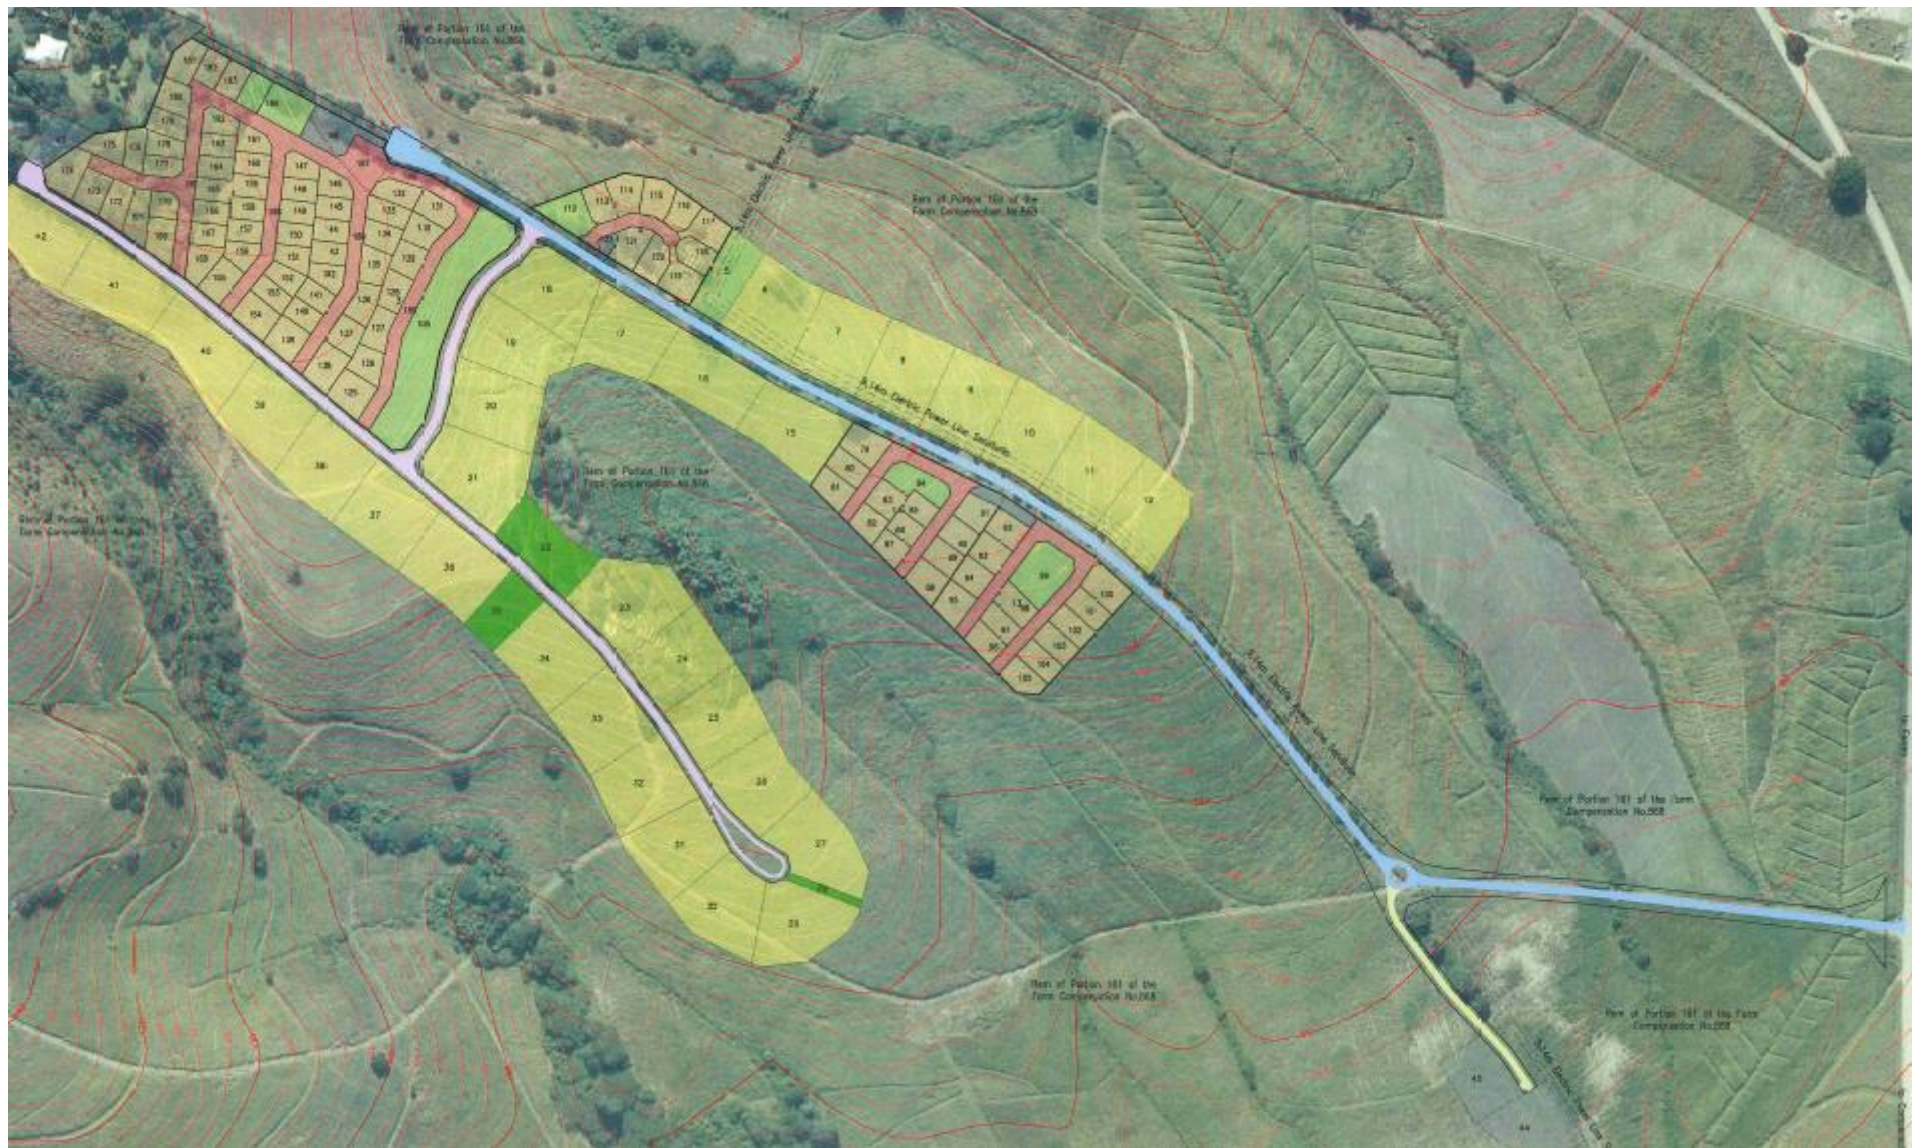
Figure 2.8: The Helmsley Country Estate internal road network

The internal road network will developed on the existing road network located on the proposed Helmsley site. There is an existing road leading from D176 to the proposed Helmsley Country Estate and numerous cane roads on the site itself. This road will require upgrading to meet the demands of increased traffic flow and the LM standards. All roads will consist of hardened surfaces and kerbing on both sides. The road surfacing material to be used on the various internal roads within the proposed development will be a Client/Architect/Urban designer specific requirement. Major culverts will be required in low laying areas and appropriately located in areas where roads cross natural drainage courses/valley lines. Please see **Figure 2.8** for the proposed internal road network and **Figure 2.9** for the location of where the existing road to be upgraded (including the installation of stormwater measures) crosses the three watercourses.

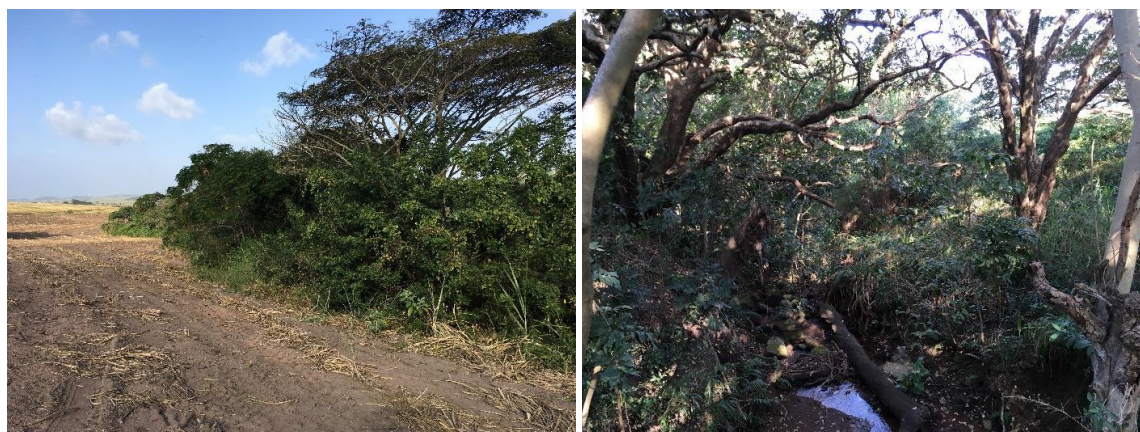
Watercourse 1 is a lower foothill river located 70m to the south of the project footprint. It is characterized by a mixed-bed alluvial channel with sand and gravel dominating the bed and by a well-defined riparian area which is dominated by indigenous tree species typical of riparian areas in the region. However, disturbance of the watercourse as a result of surrounding agricultural related activities has resulted in the proliferation of alien and invasive species.

**Figure 4.1a: Riparian vegetation of watercourse 1    Figure 4.1b: Instream habitat of watercourse 1**

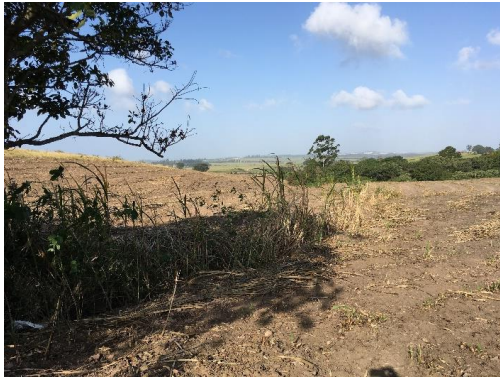
Watercourse 2 is located 10m to the south of the project footprint. Surrounding cultivation activities and associated disturbance has resulted in the loss of vegetation from both the banks and channel of the majority of the watercourse.

**Figure 4.2: Transformed habitat of watercourse 2**

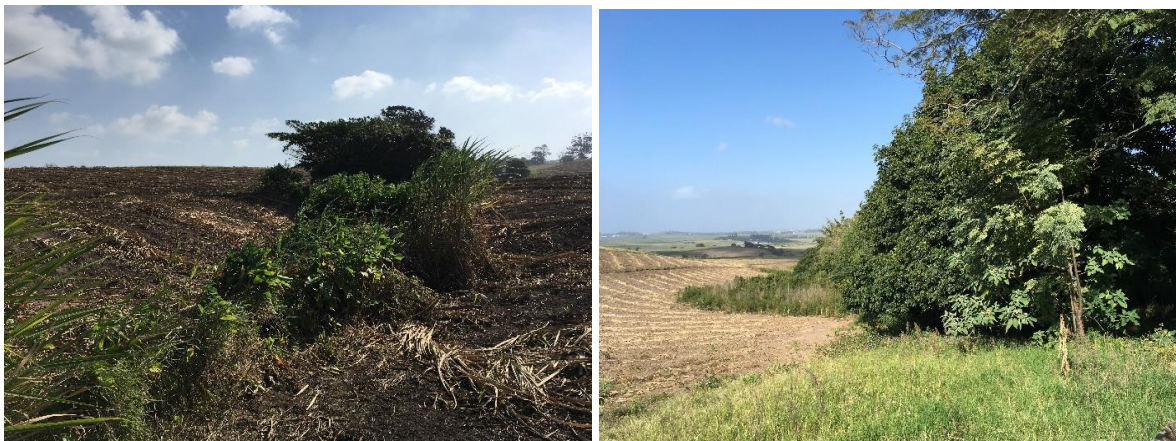
Watercourse 3 is located to the east of the project footprint. The watercourse has been significantly disturbed as a result of surrounding cultivation activities. This disturbance has resulted in the loss of natural riparian vegetation communities from both the banks and the channel of the majority of the watercourse, and in the proliferation of alien and invasive species. No development activities are proposed within this watercourse, however the development footprint is within the proposed buffer area.

**Figure 4.3: Degraded riparian habitat of watercourse 3**

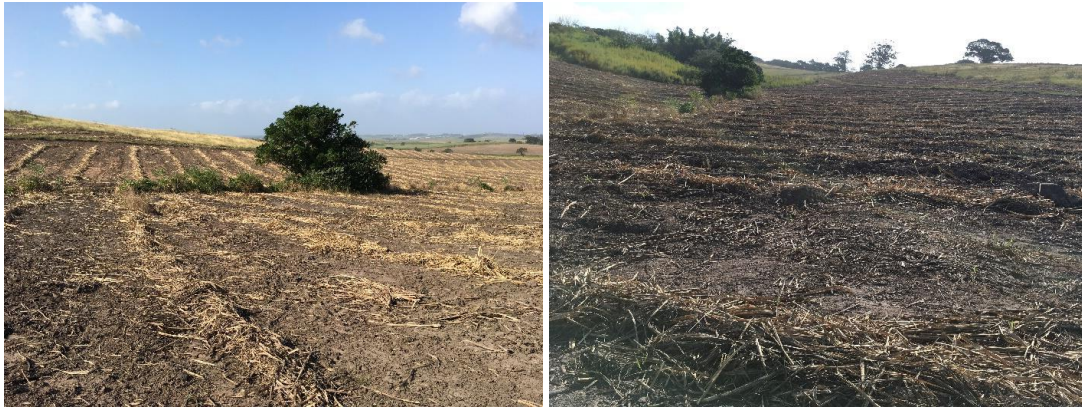
Watercourse 4 and 5 are located to the east of the project footprint and are 90m and 40m away from the proposed development. The wetland habitat associated with these features has been transformed as a result of the cultivation of sugarcane and the associated compaction and ripping of the wetland soils within the features. As result, the wetland vegetation communities along these features have been lost.

Figure 4.4a: Transformed habitat of watercourse 4    Figure 4.4b: Transformed habitat of watercourse 5

- Natural vegetation associated with watercourse 4 and 5 has been completely removed and replaced with sugarcane.
- The majority of watercourse 6 is currently under sugarcane. Only the small northern portion of the feature is dominated by secondary grassland.

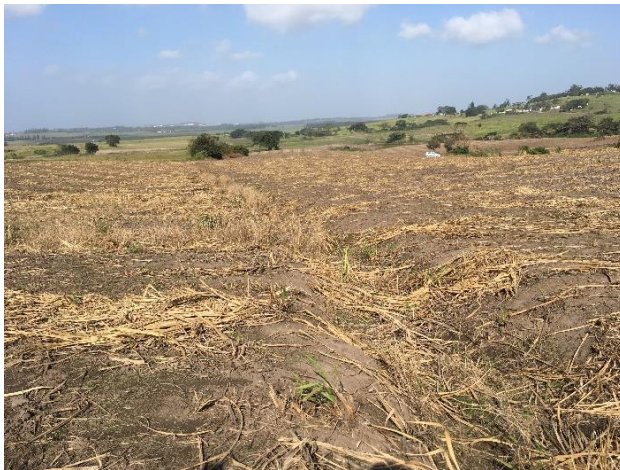
The majority of watercourse 6 is located 50m to the east of the project footprint. The majority of the wetland habitat associated with this feature has been transformed as a result of the cultivation of sugarcane.

Figure 4.5: Transformed habitat of watercourse 6

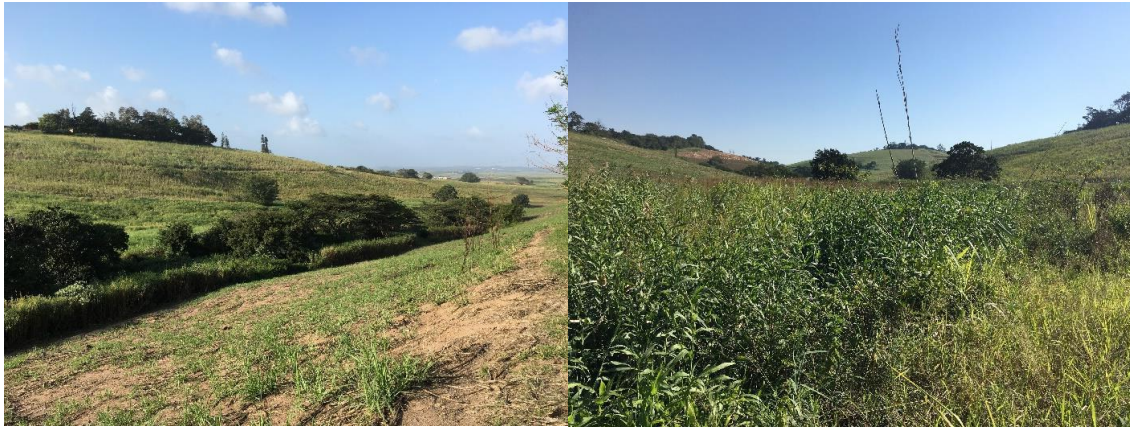
Watercourse 7 is located 90m to the north of the project footprint. This feature could be divided into two HGM Units. The upstream portion of the watercourse is characteristic of a seasonal stream (hereafter referred to as watercourse 7a and is characterized by a well-defined riparian area which is dominated by indigenous tree species commonly associated with riparian areas. Disturbance as a result of surrounding cultivation has however resulted in the encroachment of alien and invasive species

The downstream portion of the watercourse which is characteristic of a channelled valley bottom wetland (hereafter referred to as watercourse 7b). This portion of the watercourse has been significantly degraded as a result of the past and present cultivation of sugarcane within the feature and as a result of the excavation of drains within the feature which have been developed in an attempt to dry the wetland area out. This disturbance has resulted in the loss of natural wetland vegetation and in the proliferation of alien and invasive species

**Figure 4.6a: Stream section of watercourse 7    Figure 4.6b: Wetland section of watercourse 7**

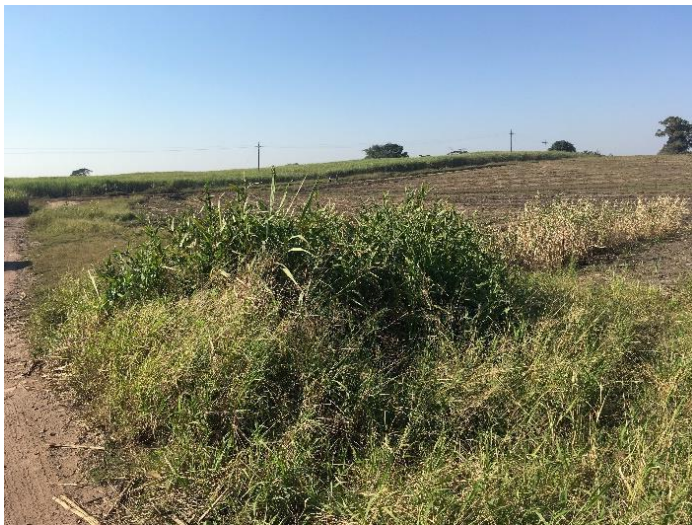
This feature has been significantly disturbed as a result of the past cultivation of sugarcane within the feature and within its catchment. Desiccation channels have been created throughout the feature in an attempt to drain excess water from the soil. Historically disturbed areas within the feature are currently dominated by alien and invasive species.

**Figure 4.7: Degraded habitat of watercourse 8**

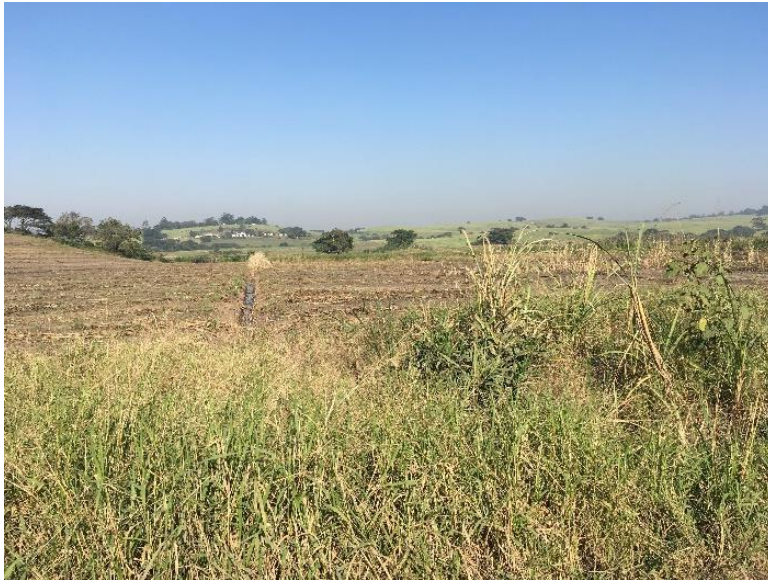
Watercourse 9 will be traversed by the access road into the proposed development. The wetland habitat associated with this feature has been transformed as a result of the cultivation of sugarcane and as a result of the excavation of an extensive drainage network within the feature. The main channel of the feature is dominated by the common indigenous obligate wetland species *Phragmites australis* and by the alien and invasive species *Coix lacryma-jobi*.

**Figure 4.8: Transformed vegetation of watercourse 9**
